Tech Tips

25-120(A): Low Signal/Noise Problem

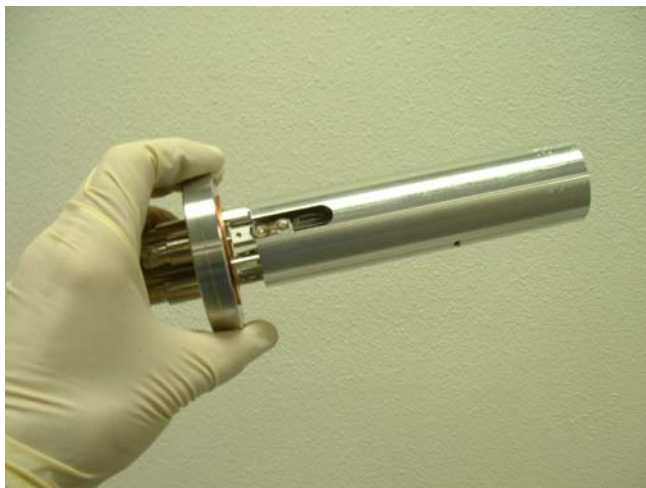
The 25-120 and 25-120A cylindrical mirror analyzers (CMA) have an electron multiplier which can be seen in Figure 1. These analyzers can be found on PHI 595, 600 and 660 Scanning Auger Systems.

Figure 1. Electron multiplier with cover

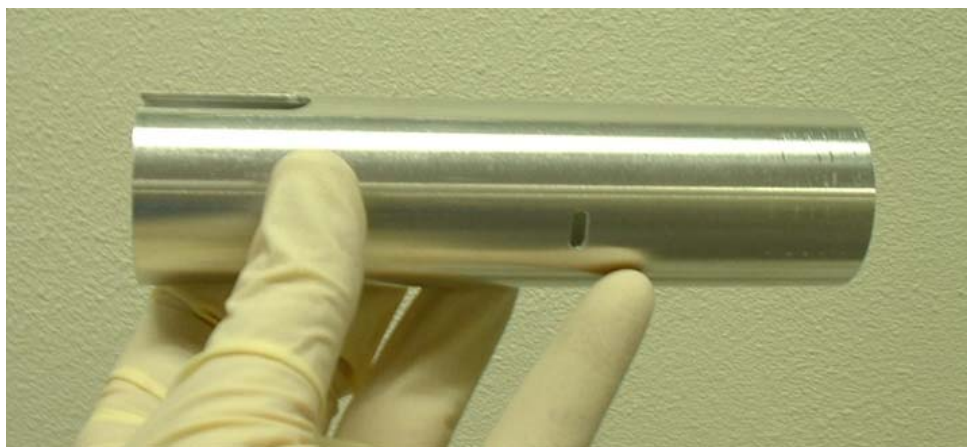
The multiplier has an aluminum cover (Figure 2) that can slide down and short out the collector housing. When this happens, the signal to noise ratio is reduced by a factor of three. Fortunately, this is an easy problem to diagnose and fix.

Figure 2. Multiplier cover

1. Vent the system and remove the electron multiplier from the CMA.
2. Slide the cover off of the multiplier.
3. Cut off ¼" of the cover from the end that is closest to the collector housing. In Figure 2, this is the right side of the picture.
4. "De-burr" the cover and clean it with a laboratory cleanser such as Alconox, followed by isopropanol, to remove any oils deposited during the cutting process.
5. Install a new gasket on the multiplier flange.
6. Slide the cover back over the multiplier assembly.
7. Re-install the electron multiplier into the CMA. See Figure 3.
8. Measure the NEG connector to the CMA to make sure that the resistance is now 3.0 Meg ohms.
9. Pump down the system.
10. Bake the system.

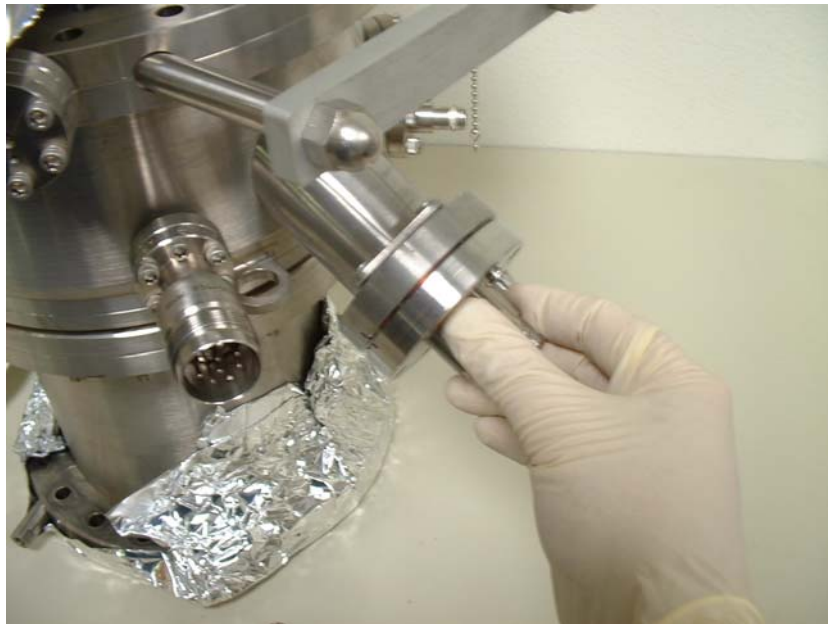
Figure 3. Reinstalling the multiplier into the CMA
