Tech Tips

PHI X-ray Source Bake-Out Tips

Two potential x-ray source problems may occur after baking-out a PHI XPS system. Their causes are listed below by source type.

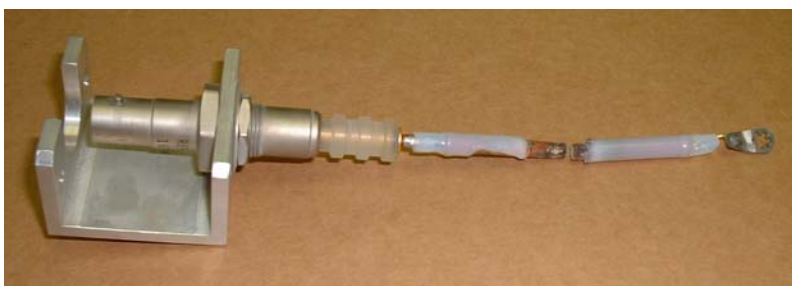
When you bake-out the 04-500/04-548 x-ray source you must first remove the Teflon cooling lines and high voltage (HV) connector from the anode and drain the water out of the source. Most 04-500 and 04-548 anodes have a 1 k Ω 15 kV resistor between the HV connector and the anode, others have just a wire. In both cases, it is essential that after the bake-out the HV connection to the anode is tight. If it is not, the source or system electronics can be damaged by source arcing. The picture below shows a 1k ohm resistor that was destroyed because the resistor connections were not tightened properly after system bake-out.

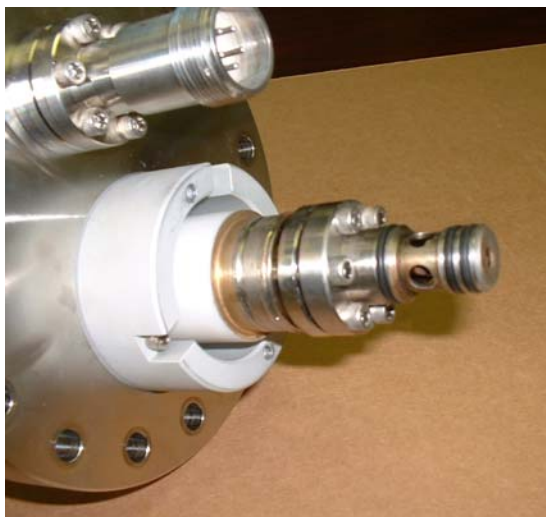
When the 10-550/10-560 x-ray source is baked-out, the Teflon block that directs the water into and out of the source needs to be removed. Also remove the Viton O-rings on the anode that are exposed after the Teflon block has been removed. If the O-rings are not removed for bake-out, they will dry out and cooling water will leak past them during normal operation of the x-ray source. The result is that carbon arc lines form inside the Teflon block that eventually cause water leaks and/or high voltage leakage across the anode. This problem is easily prevented by simply removing the O-rings before the system is baked-out. A picture of the O-rings is shown to the right.
