### UV surface cleaning by the RBD mini Z system

Type of analysis: XPS at ion beam sputtered ITO thin films

Dr. Jens Bauer / Leibniz Institute of Surface Engineering (IOM) Randy Dellwo / RBD instruments

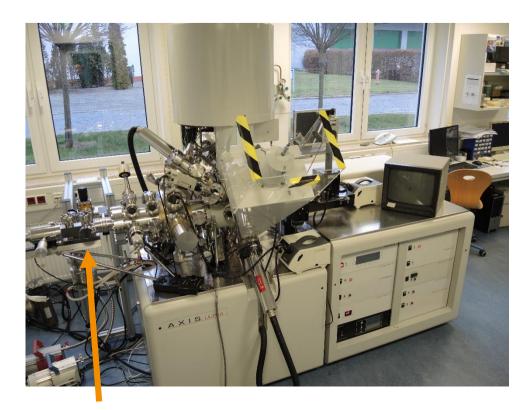
XPS equipment: Kratos Ultra DLD

- excitation with monochromatic Al  $K_{\alpha}$ radiation (1486.6 eV)
- hemispherical analyser: measurement with 40 eV pass energy
- delay line detector
- analysis spot size: 700 x 300 μm²
- step width of the detail spectra: 0.1 eV
- $\sim$  spectra calibration to In 3d:  $E_B = 444.5$  eV
- generally in XPS: no direct information about hydrogen and helium possible, only if compound peaks can be doubtless assigned

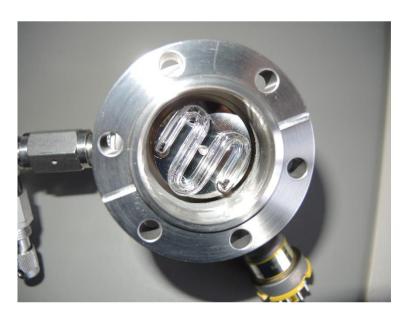
# UV cleaning equipment at the load-lock chamber HV cleaning operation

- (1) miniZ system with power supply
- (2)  $O_2$  gas supply
- (3) RGA system

UV equipment: RBD mini Z

- 185 nm UVC radiation:
   350 μW/cm² @ 6 cm distance
- Typical application field: water vapor desorption in vacuum systems
- ✓ O₂ background gas pressure in high vacuum range: 10<sup>-4</sup> mbar

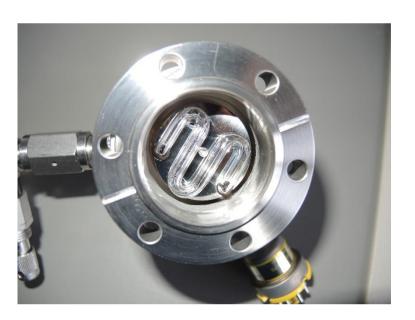
# UV cleaning equipment at the load-lock chamber FV cleaning operation

- (1) miniZ system with power supply
- (2)  $O_2$  gas supply
- (3) Full range pressure gauge

UV equipment: RBD mini Z

- 185 nm UVC radiation:
   350 μW/cm² @ 6 cm distance
- Typical application field: water vapor desorption in vacuum systems
- ✓ O₂ background gas pressure in fine vacuum range: 10 mbar
